CASE HISTORY®

CHS-0008 Chlorinated Compounds(TCA- DCA- DCA)

Site 0008 - Site Information

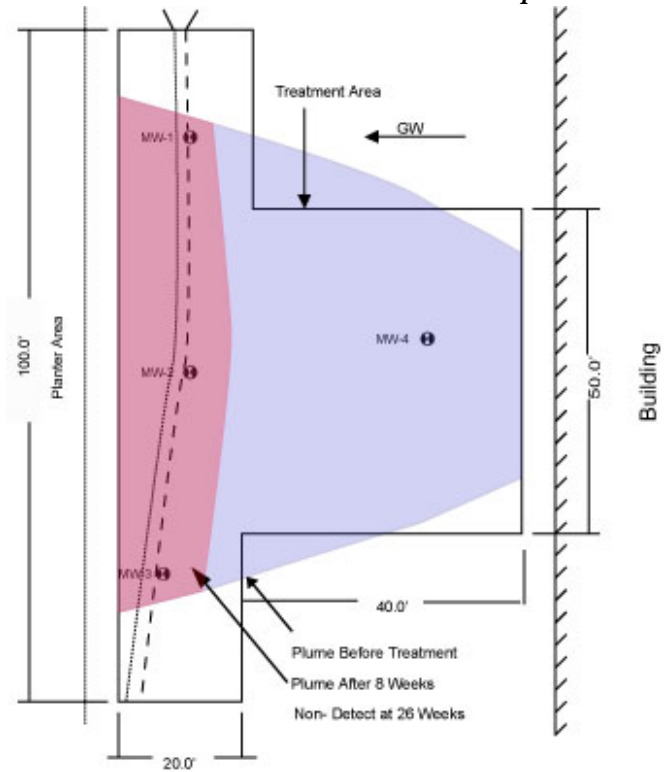
Review of Site Map shows an underground electrical utility corridor traversing the length of the injection area nearest the property line. It also reveals that monitoring wells MW-1, MW-2 and MW-3 are located in this corridor. During the injection work care was taken not to impact the underground electrical cables with the direct push equipment. Consequently, the two (2) rows of injection points on either side of the utility corridor were shifted away from the electrical lines to accommodate safety concerns. This inadvertently left the monitoring wells located in the utility corridor in an area not immediately impacted by the reagent. It was decided that because the groundwater was flowing perpendicular to the corridor, the reagent should eventually reach these monitoring wells. Data collected approximately six (6) months after the application indicated that the concentrations of contaminants in the wells had dropped below maximum contaminant levels (MCLs) for site closure.
